# HYDROQUIP™

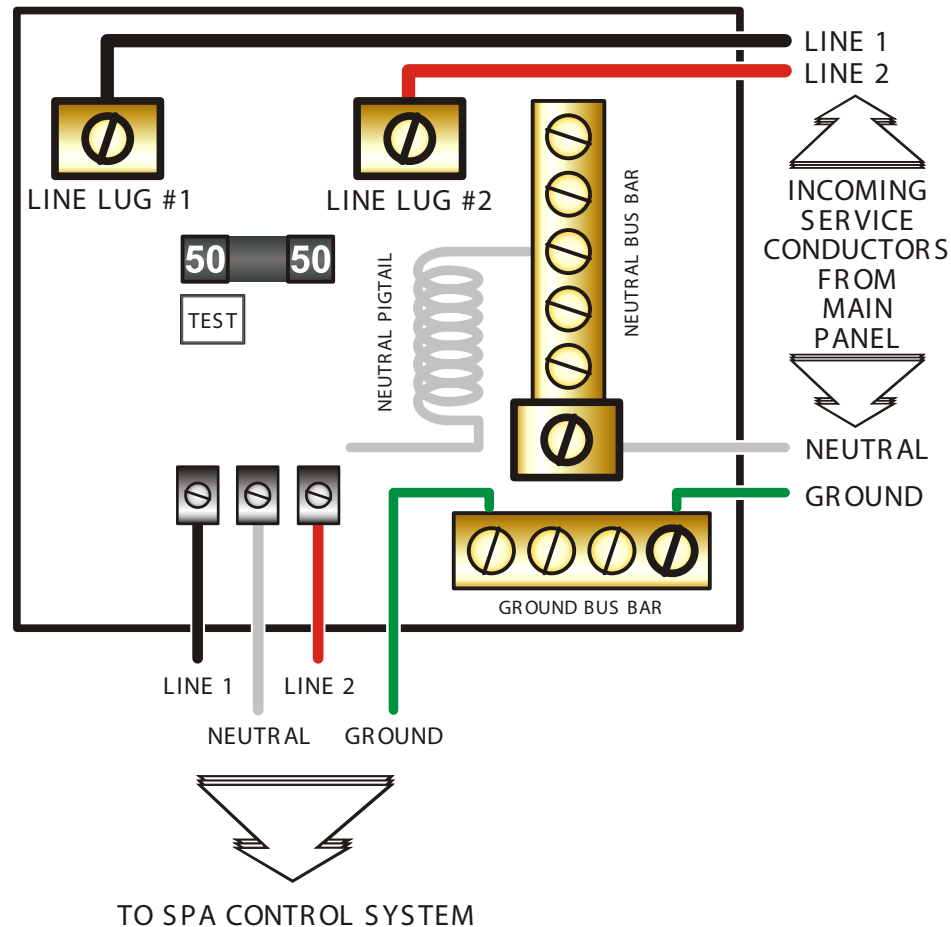
The number one cause for repeated tripping of a GFCI breaker on a new install is that the breaker has been incorrectly wired. The illustration below shows a typical installation. Note that the Neutral pigtail is connected at the neutral bus bar and the Neutral wire coming from the spa control system is connected directly to the breaker. Connecting the Neutral wire from the spa control system to the Neutral bus bar will cause the repeated tripping. **WARNING** - The illustration is meant to be used as a guide ONLY. This does not in any way supercede any manufacturers installation instruction.
